APOLLO 15 MISSION REPORT

MANNED SPACECRAFT CENTER  
HOUSTON, TEXAS  
DECEMBER 1971

Mission Evaluation Team

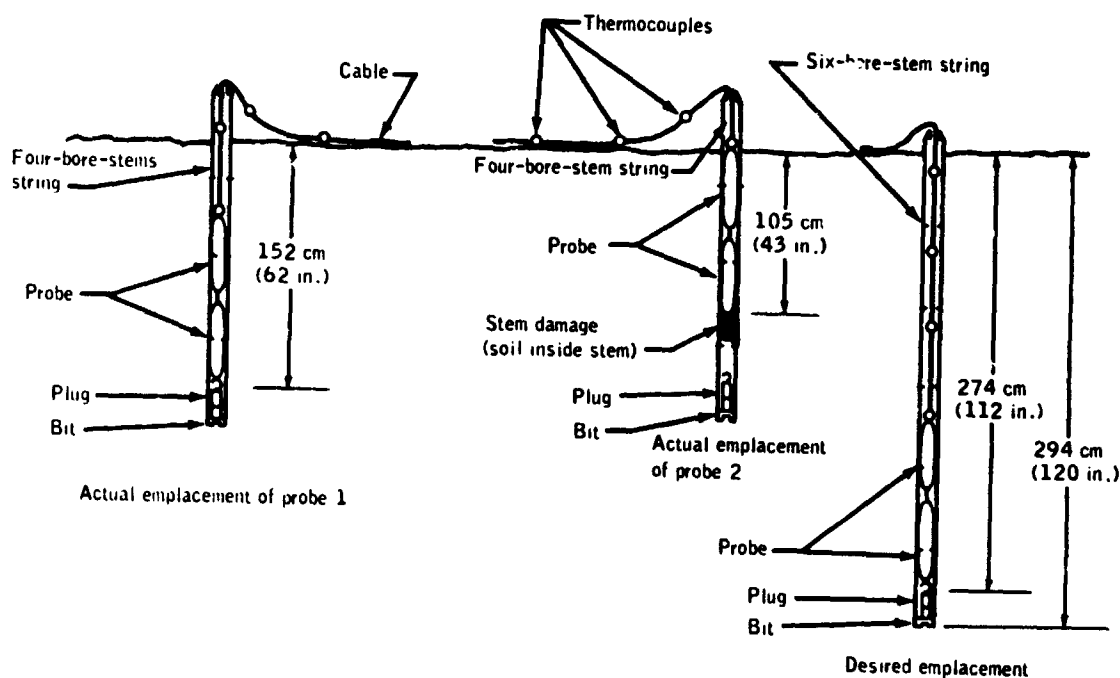
Figure 4-6.- Heat flow experiment bore-stem and probe emplacement.

Deployment of the heat flow experiment was started on the first extravehicular activity and completed on the second extravehicular activity. A minor problem was experienced in removing two Boyd bolts that fasten the heat flow experiment components to the subpallet and problems were encountered in drilling the holes for two probes and emplacing the second probe. Refer to sections 4.11 and 14.4.1 for further discussion. The electronics box was placed about 9 meters (30 feet) north-northeast of the central station. The first probe hole was drilled about 4 meters (12 feet) east of the electronics box and the second, about 4.5 meters (15 feet) west of the box. The first hole was drilled to a depth of about 172 centimeters (70 inches) and probe 1 was emplaced during the first extravehicular activity, but the drilling of the second hole and emplacement of probe 2 was deferred because of time constraints. Drilling was resumed at the second hole during the second extravehicular activity and a hole depth of about 172 centimeters (70 inches) was again achieved; however, damage to a bore stem section (sec. 14.4.1) prevented probe 2 from reaching the bottom of the hole. The first heat flow experiment probe extends from a point 47 centimeters (19 inches) below the surface to a point 152 centimeters (62 inches) below the surface. Because of the damage to the bore stem in the other hole, the second probe extends from the surface to 105 centimeters (43 inches) below the surface (see fig. 4-6).

The experiment was turned on at 1947 G.m.t., July 31, and valid temperature data were received from all sensors. Because of the shallow emplacement of probe 2, high near-surface temperature gradients will keep the differential thermometers on the upper section off-scale during most of a lunar day-night cycle. The lower section of probe 2 and both the upper and lower sections of probe 1 are returning valid data on subsurface temperatures. Sensors on these sections that are shallower than 80 centimeters (32 inches) are seeing the effects of the diurnal cycle of surface temperature, but these variations are well within the range of measurement. Lunar surface temperatures are being obtained from five of the eight thermocouples in the probe cables that are just above or on the lunar surface because of the shallow emplacement.

The performance of the drill power-head and the core stem was good. However, full depth penetration with the bore stems was a problem and extraction of the core stems from the hole was difficult (see sec. 14.4.1). The two bore stem holes were drilled to a depth of about 172 centimeters (70 inches) instead of the desired 294 centimeters (120 inches), with one of the bore stem strings probably sustaining damage at a point slightly above the first joint [about 105 centimeters (43 inches) below the surface] (see fig. 4-6).

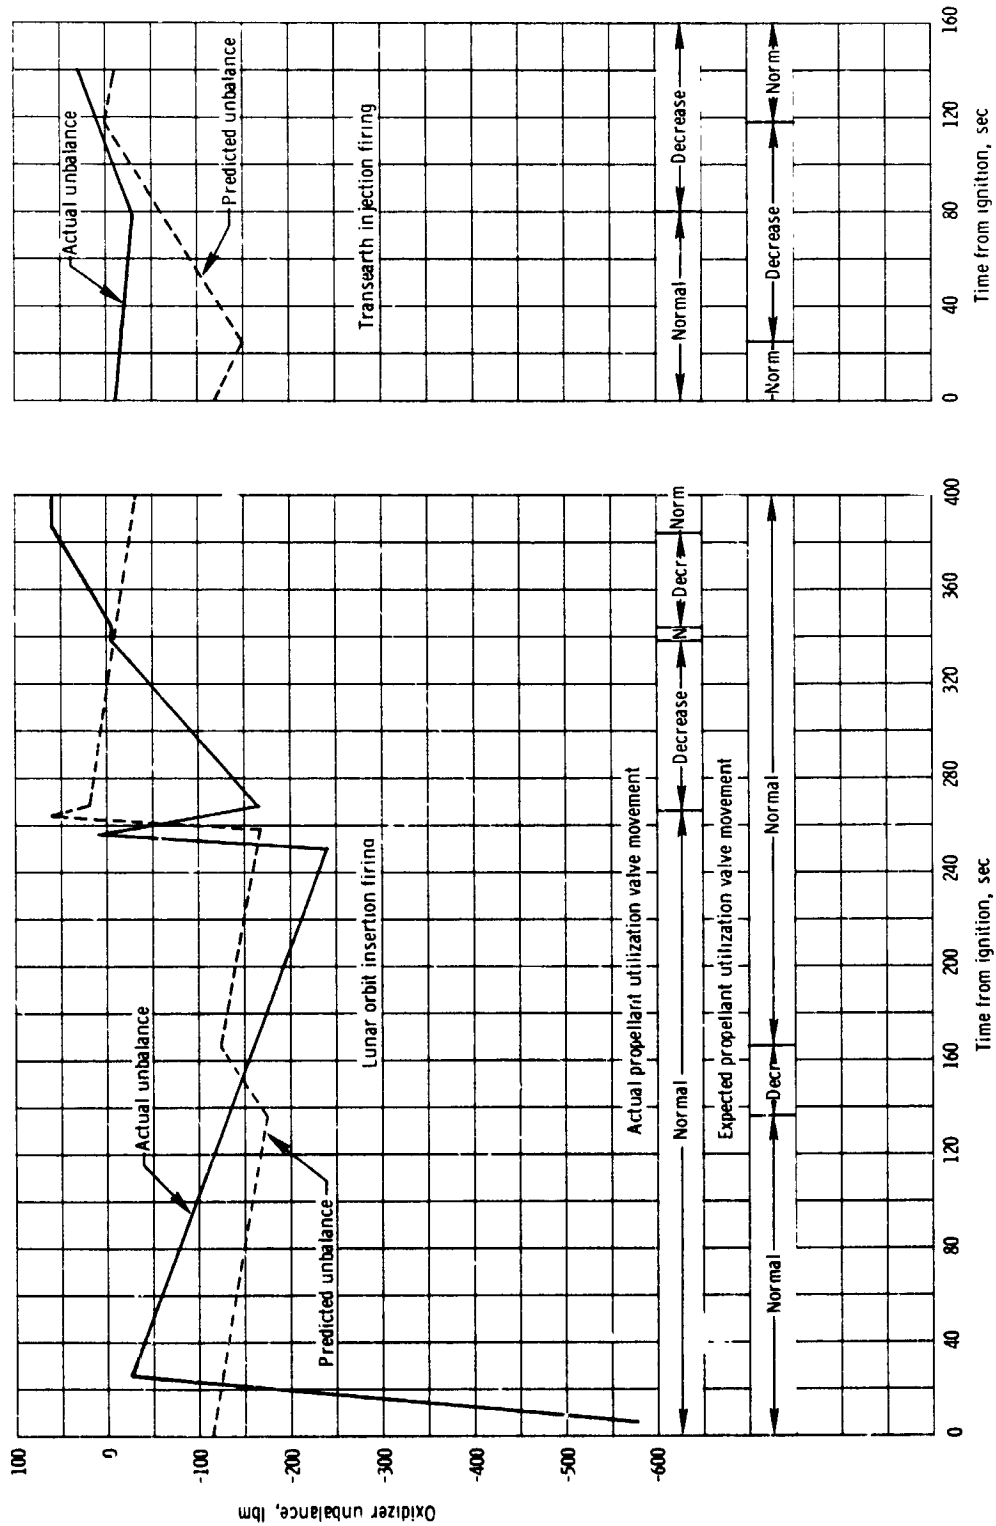
Figure 6-3.- Propellant imbalance during the lunar orbit insertion and transearth injection firings.

Previous flight results have shown the inflight mixture ratio to be significantly less than expected from engine acceptance test data. The service propulsion system engine was re-orificed to increase the mixture ratio for this mission. Figure 6-3 shows the propellant unbalance for the two major engine firings compared with the predicted unbalance. The unbalance at the end of the transearth injection firing was very small and shows that the modifications to the engine were satisfactory.

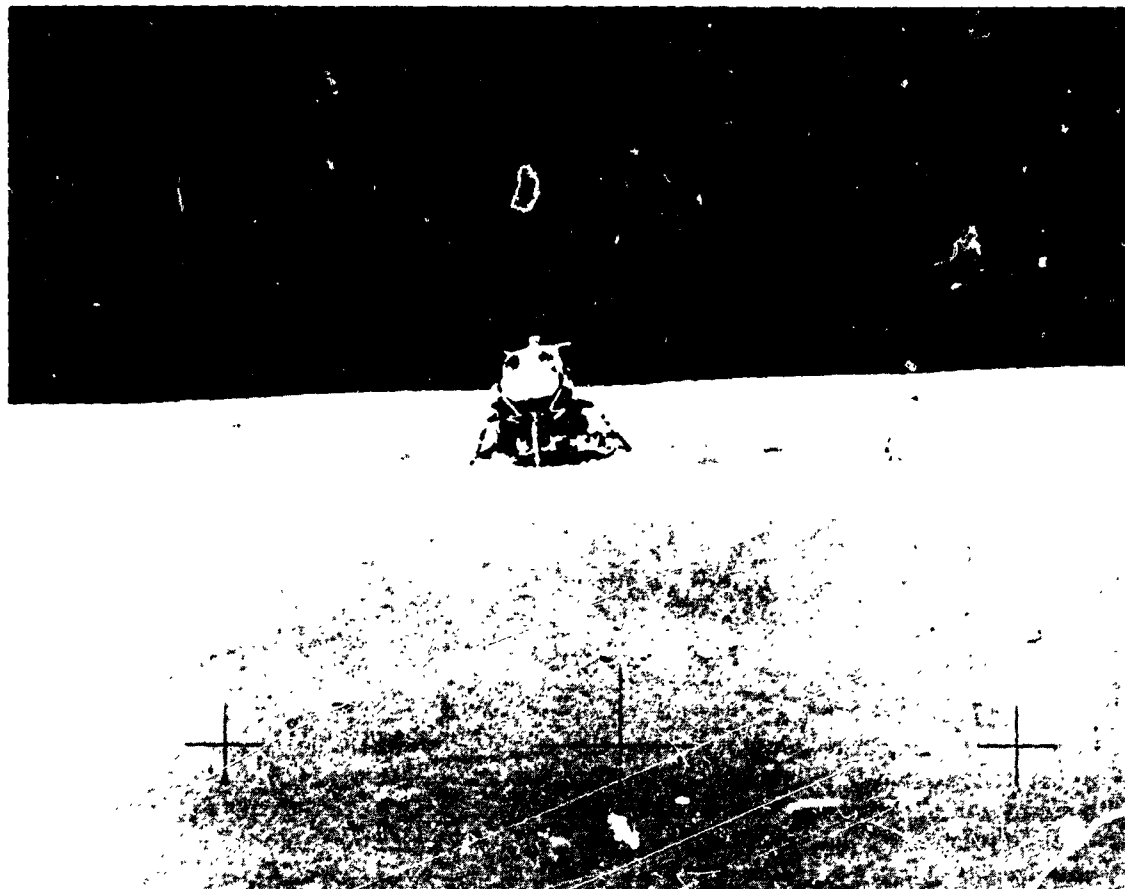
Figure 7-2.- Attitude of lunar module on lunar surface.

The vehicle contact velocity and attitude data at touchdown show that the landing was very stable in spite of the relatively high lunar surface slope at the landing point. The plus-Z and plus-Y footpads contacted the lunar surface nearly simultaneously, providing a nose-up pitch rate of 17 deg/sec and a roll rate to the left of 15 deg/sec. Final spacecraft settling occurred 1.8 seconds later. The vehicle at-rest attitude, as determined from the gimbal angles, was 6.9 degrees pitch up and 8.6 degrees roll to the left, resulting in a vehicle tilt angle on the lunar surface of approximately 11 degrees from the horizontal (fig. 7-2).

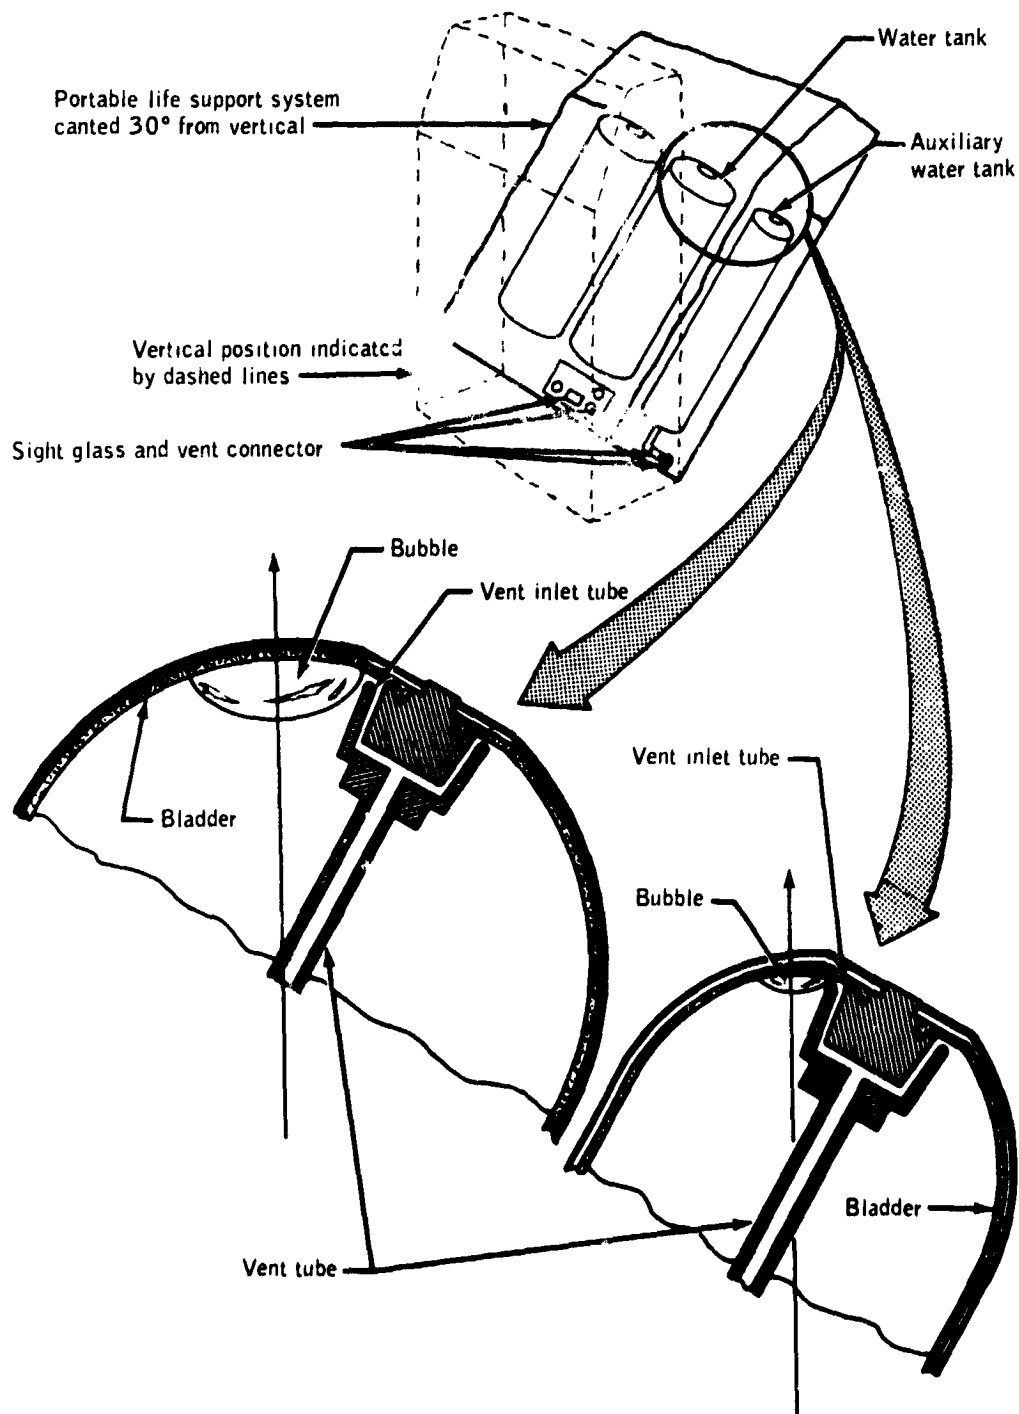
Figure 8-1.- Effect of tilt during water recharge

Checkout of the Commander's portable life support system prior to the first extravehicular activity was normal. Portable life support system startup for the Lunar Module Pilot was normal until the feedwater was turned on. The feedwater pressure increased faster and higher than expected. A warning tone and, a short time later, a vent flow flag was activated. The trouble was traced to a gas bubble trapped in the feedwater bladder during charging by the flight crew (fig. 8-1). The gas bubble caused high feedwater pressure. Until the feedwater pressure had decayed to the suit pressure level, the condensate stowage volume was blocked by the feedwater bladder. This resulted in the water separator becoming saturated and allowing droplets of water to be carried over to the fan. This can reduce the fan speed, thereby activating the vent flow flag. Data confirmed the presence of current spikes which are a characteristic of water droplets hitting the fan.

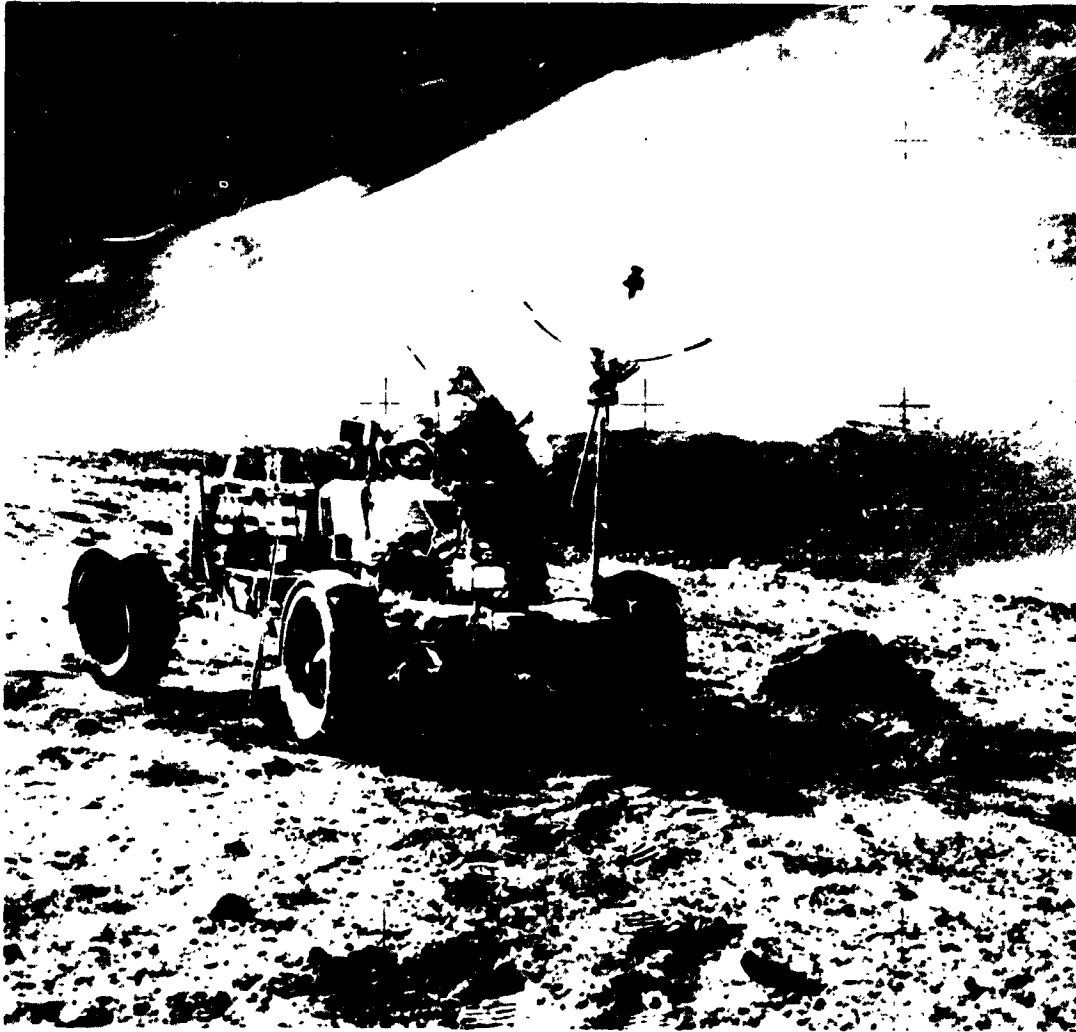
Figure 8-2.- Lunar roving vehicle.

The lunar roving vehicle (fig. 8-2) performed well during the mission. During the three lunar surface extravehicular activities, the vehicle traveled 27.9 kilometers (15.1 miles) during 3 hours and 8 minutes of driving at an average speed of 9.2 kilometers (4.97 miles) per hour. A total of approximately 52 ampere-hours was consumed. Navigation errors were within expected tolerances with small distance errors and no apparent gyro drift. The combined wander and wheel slip factor was within predicted limits.

The front-wheel steering was inoperative during the first extravehicular activity, but operated normally for the second and third extravehicular activities. Simultaneous front- and rear-wheel steering was found to be more sensitive than desired, and difficulties were experienced with the seat belts; but overall, the crew was very pleased with the vehicle's performance, particularly, the speed and hill-climbing capability.

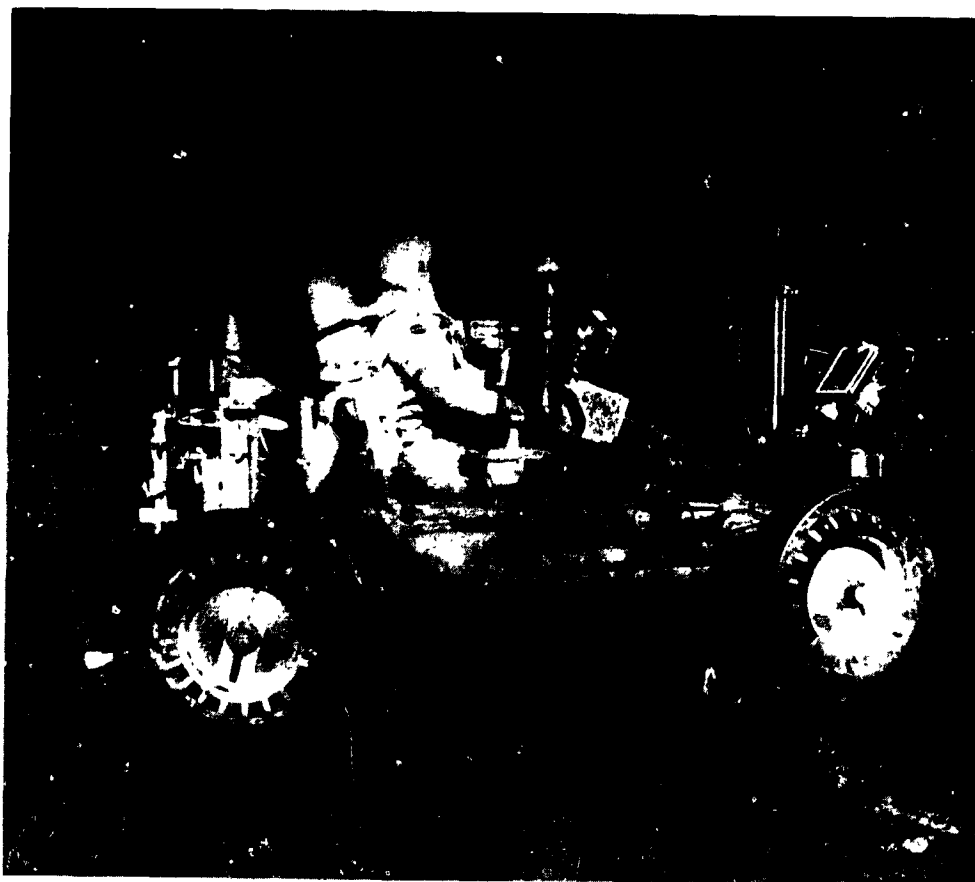
Front steering was inoperative during the first extravehicular activity. All switches and circuit breakers were cycled a number of times

Figure 9-5.- Commander seated on the lunar roving vehicle.

during the early portion of the first extravehicular activity with no effect on the steering. Subsequently, at the beginning of the second extravehicular activity, cycling of the front steering switch apparently enabled the front steering capability which was then utilized throughout the remaining traverses.

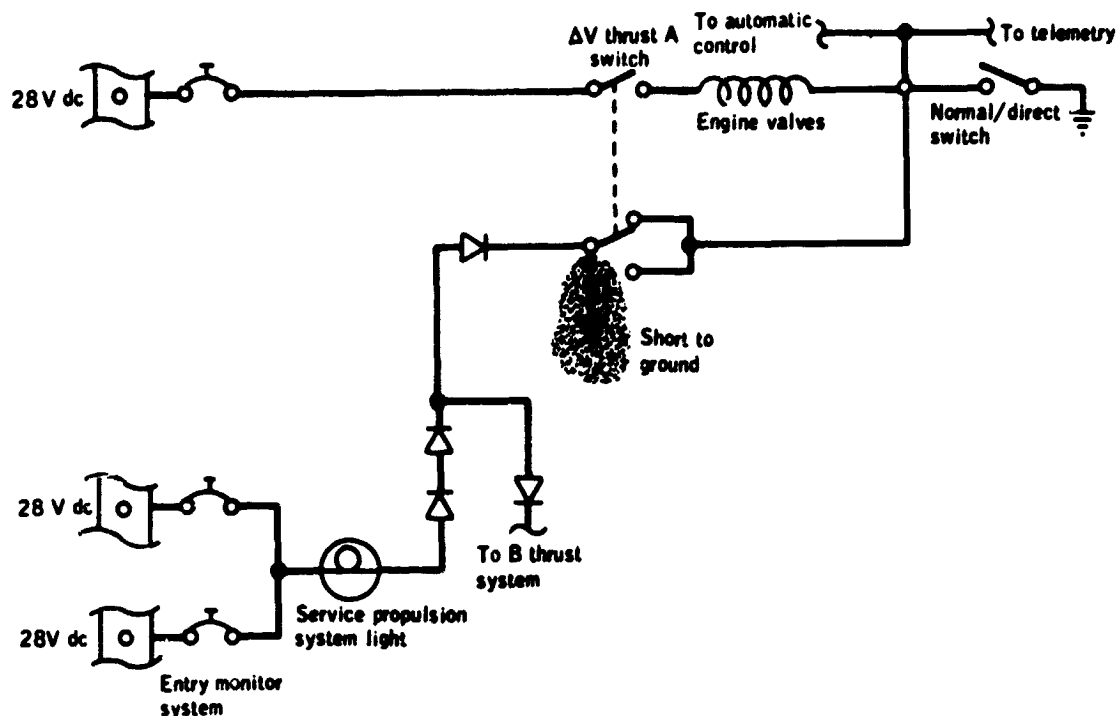
The short was isolated to the system A delta-V thrust switch which was found to be intermittently shorted to ground (fig. 14-3). A test firing performed at 28:40:22 verified that the short existed on the ground side of the service propulsion system pilot valve solenoids.

Figure 14-3.- Service propulsion system thrust light circuitry.

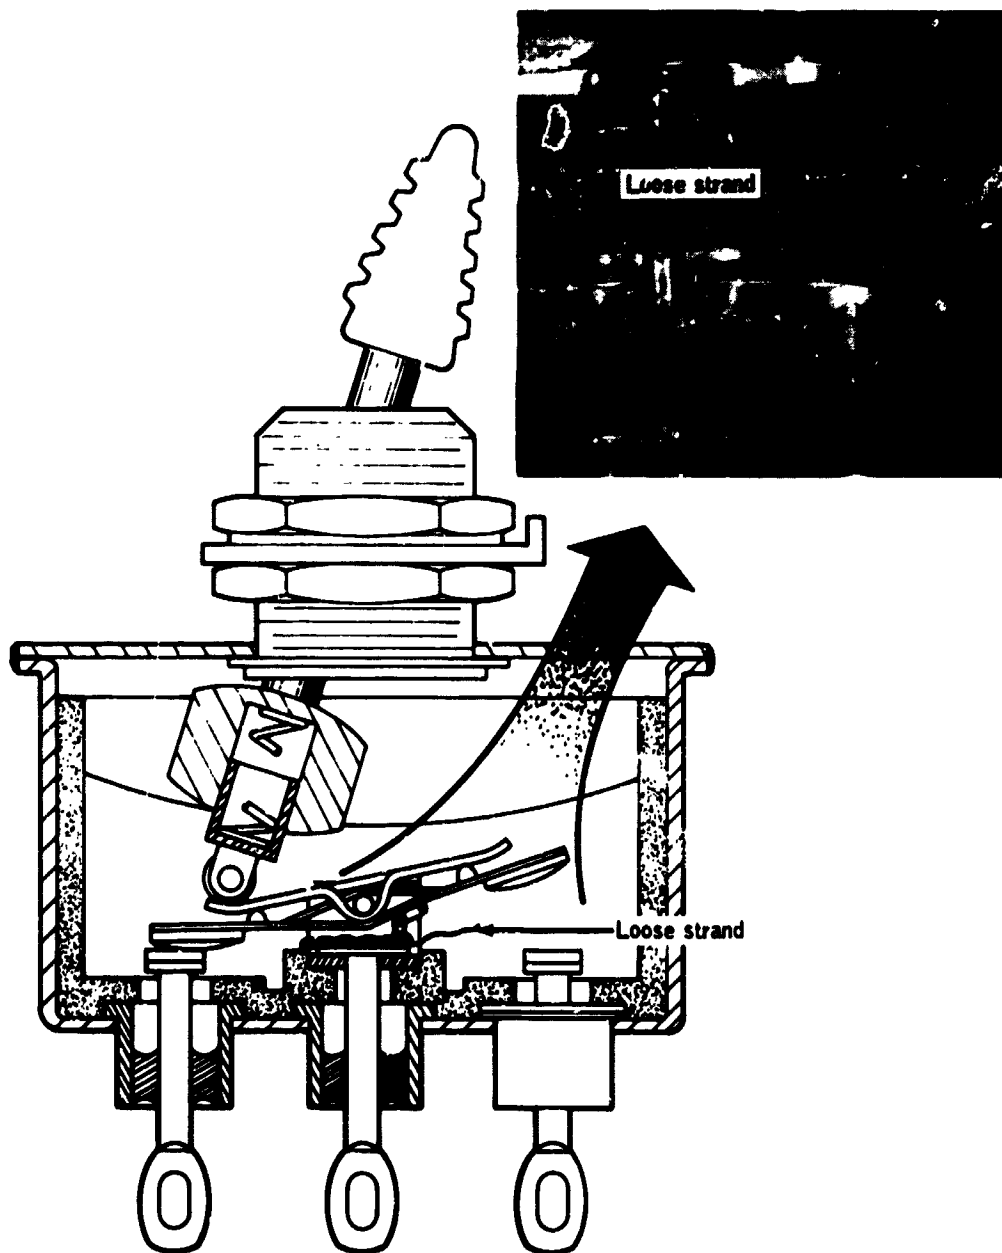
The delta-V thrust switch (fig. 14-4) was shorted to ground both before and after removal of panel 1 from the command module during post-flight testing. After a change in panel position, the short-to-ground disappeared. The switch was then removed from the panel and X-rayed. The X-rays showed a wire strand extending from the braid strap which was thought to have caused the grounding problem. After switch dissection, an internal inspection verified that a strand extended from the braid strap; however, it did not appear to be long enough to cause a ground at any point within the switch (fig. 14-4). The bracket assemblies (pivot brackets, pigtail braids, and movable contacts) and the plastic liner were removed from the switch. Microscopic examination revealed that a wire strand (approximately 0.055 inch long) was present on the flange on terminal 2 (fig. 14-5). The strand appeared to be attached, but was later moved quite easily.

Figure 14-4.- Service propulsion system delta-V thrust switch.

Most of the switches on Apollo 16 and 17 spacecraft (3000 or 4000 series) required for crew safety or mission success were screened according to the following procedures.

- a. Additional inspection points were employed during manufacturing.
- b. The switches were X-rayed prior to acceptance testing.

c. The acceptance vibration test was 3-axis random (4000 series) or single-axis sinusoidal (3000 series) test.

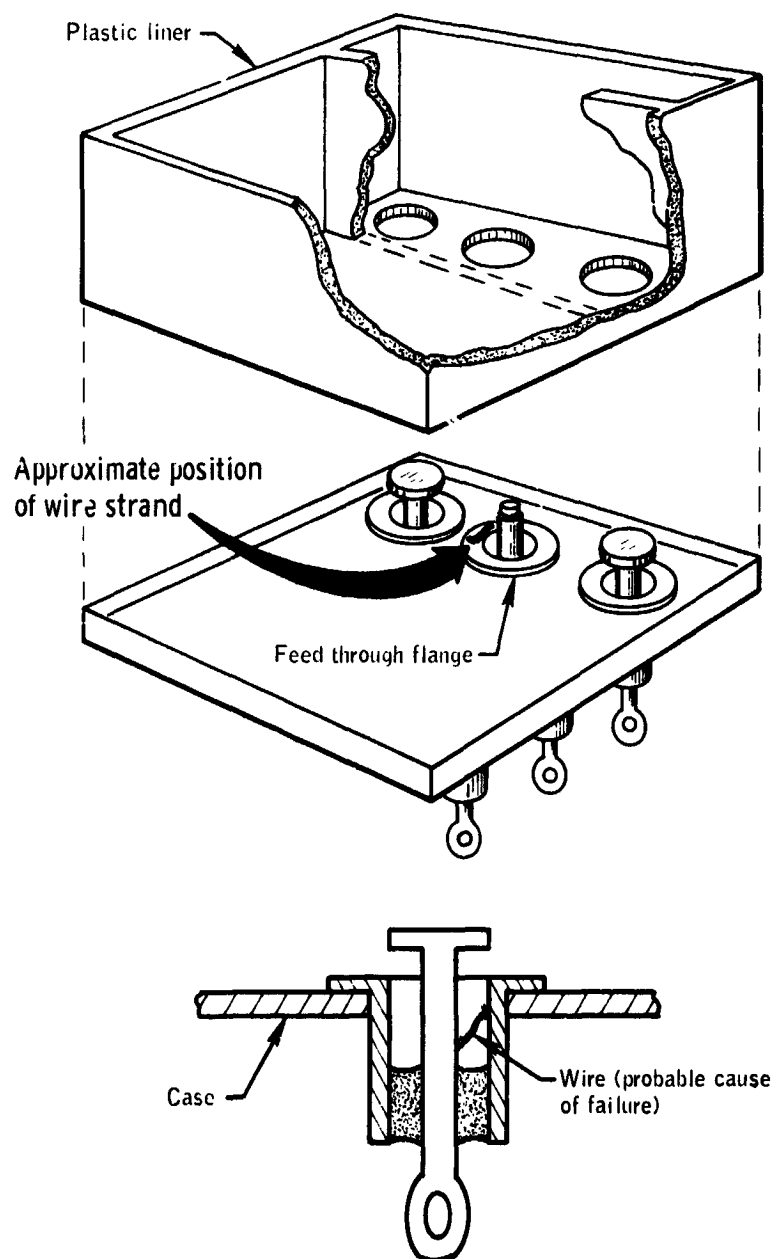
The bottom of the plastic case liner was examined, and showed no evidence of a scratch or deformation conforming to the shape of the wire strand. A sample wire strand was placed on a feed-through flange of a scrap switch unit, and the plastic case liner was pressed on as would occur during normal switch assembly. When the scrap switch was disassembled an indentation in the plastic case liner was readily apparent. This test indicated that the strand could not have been trapped between the case

liner and the flange surface; therefore, it is postulated that it might have been enclosed in the cavity of feed-through terminal 2 (fig. 14-5). The maximum clearance between the interior of the feed-through terminal wall and the terminal itself is 0.040 inch. A 0.055-inch-long wire strand could easily have bridged this distance, and yet is short enough to move quite freely within the feed-through terminal cavity. In fact, the strand subsequently fell into the cavity. Examination of the strand and cavity wall showed evidence of arcing. The strand could not be detected on the X-rays because that area was obscured by other poles in the switch.

Figure 14-5.- Disassembled service propulsion system thrust switch.

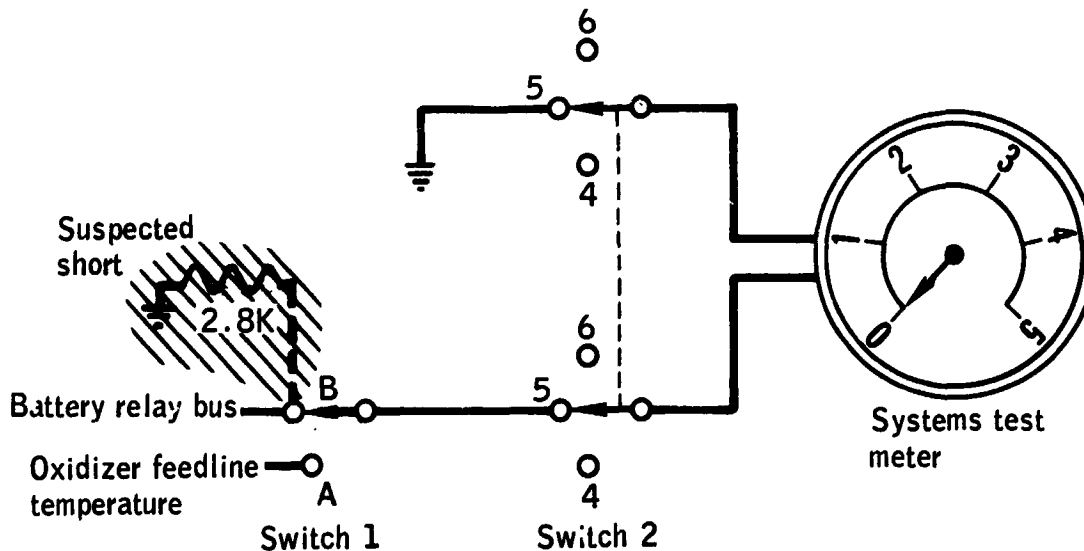
Postflight testing of the vehicle and all of the involved components revealed no anomalous condition which could have caused the problem but did isolate the problem to the instrumentation circuitry and verify that the functional operation of the bus was not impaired. Analysis indicates that the only way to duplicate the flight problem would be to connect a resistance of 2800 ohms from ground to the battery relay bus measurement circuit (fig. 14-6). No resistance near this magnitude was measured during postflight testing. The most probable cause of the anomaly was that insulation resistance at the output terminal of the switch was lowered because of humidity.

Figure 14-6.- Systems test meter switch.

This is the only time that a problem of this type has occurred during the Apollo Program and the probability of recurrence is considered to be very low. If the problem does occur again, other measurements are available for the determination of the battery relay bus voltage.

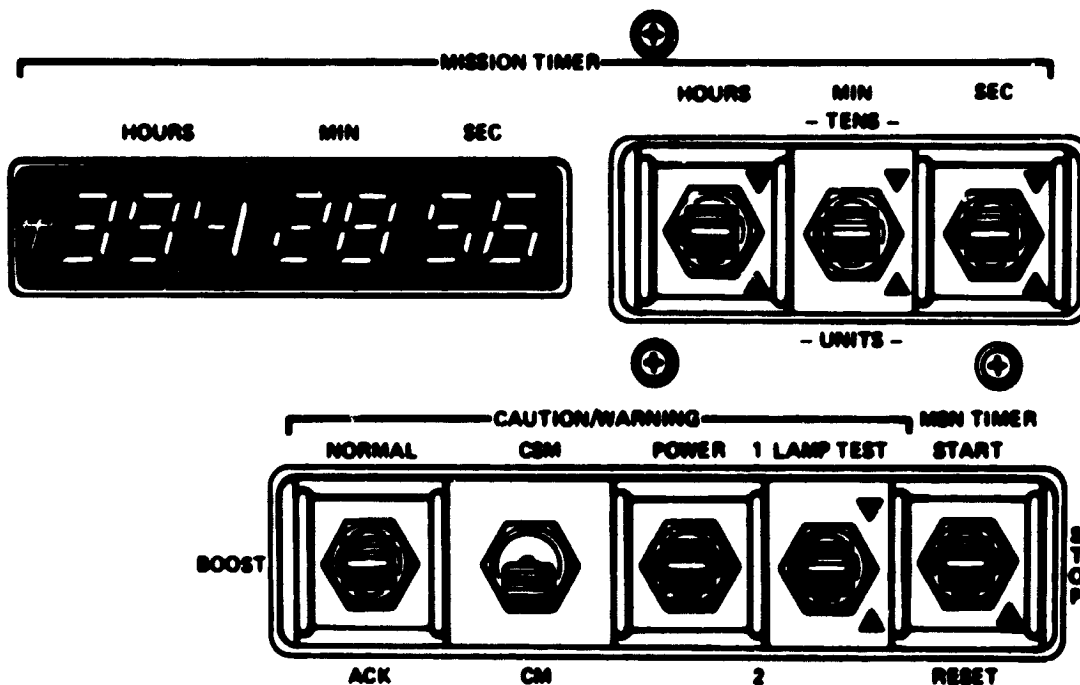
Figure 14-10.- Mission timer.

The panel 2 mission timer stopped at 124:47:37. Several attempts to start the clock by cycling the start/stop/reset switch from the stop to the start position failed (fig. 14-10). The timer was reset to 124:59:00 using the hours, minutes, and seconds switches, and the timer again failed to start when the switch was cycled. The switch was then placed in the

reset position. The timer reset to all zeros and started to count when the switch was placed in the start position. The timer was then set to the proper mission time using the hours, minutes, and seconds switches and operated properly for the remainder of the mission.

The timer and all associated equipment were still operating properly after the flight. Thermal, vacuum, and acceptance tests were performed and the cause of the failure could not be determined. Circuit analysis showed that the problem could be caused by one of five integrated circuits on the mounting board circuitry. These suspect components were removed and tested with negative results.

The failure was most probably caused by an intermittent problem within a component which later cured itself. If the problem occurs on a future mission and the timer will not restart, mission time can be obtained

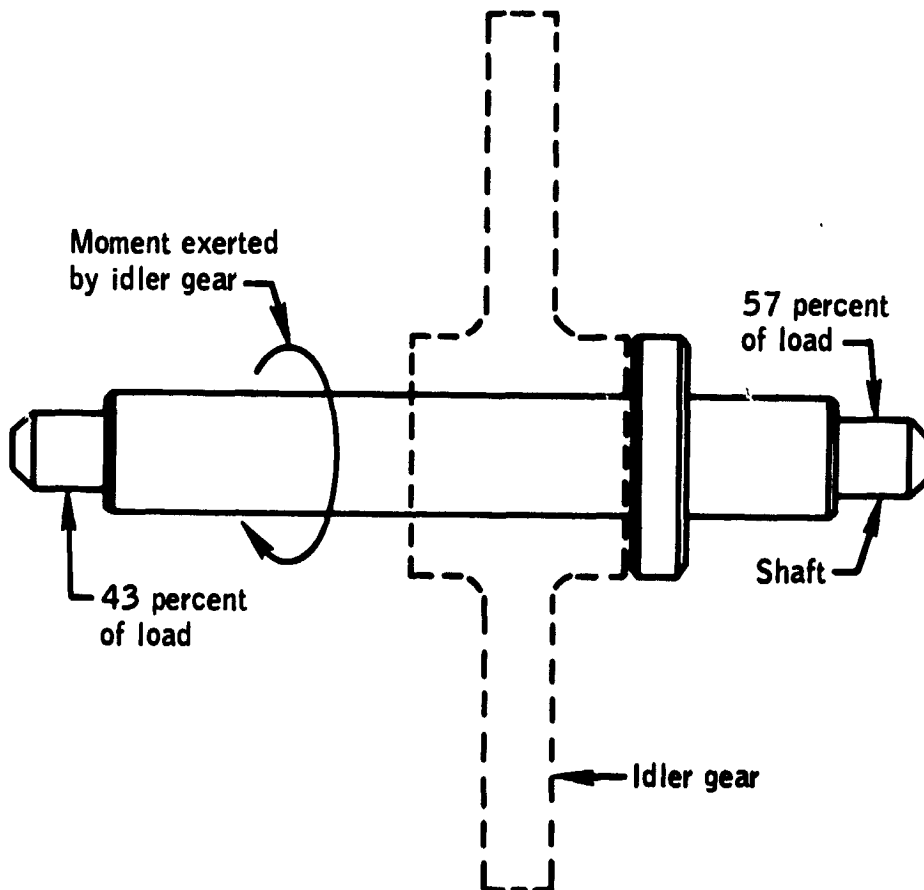
Figure 14-16.- Forces on idler gear shaft in countdown mode.

The idler gear is free to rotate on the shaft (fig. 14-16); however, the design allows the stainless-steel shaft to also rotate. The stainless-steel shaft bearing points are in the magnesium motor plate and the shaft rotation wears away the softer magnesium material.

Inspection of the unit showed that the magnesium bearing points had been elongated as shown in figure 14-17. Torque from the stepping motor applied to the idler gear not only resulted in rotation of the shaft but also caused the shaft to tilt (fig. 14-17). The wearing eventually allowed the shaft to tilt sufficiently to cause the gear to rub against the

Units for future flights will be visually inspected by looking through the window for paint flakes and signs of wear.

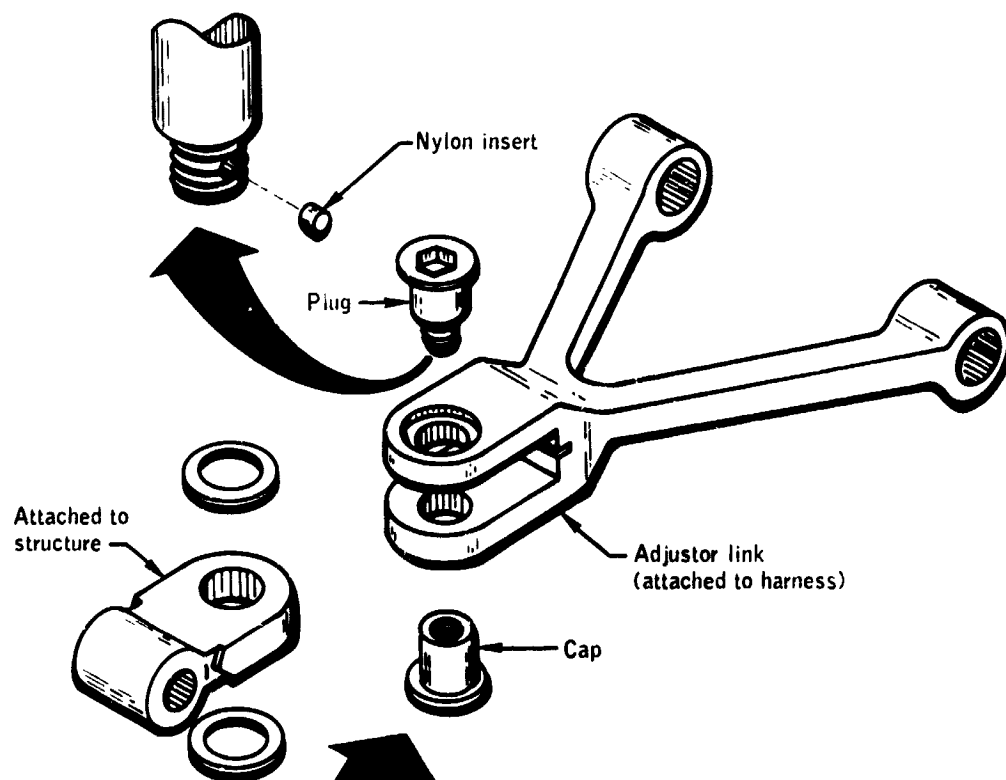
Figure 14-18.- Crew restraint harness connector.

The plug-and-cap assembly (fig. 14-18), which is part of the universal assembly that attaches the restraint harness to the couch seatpan, separated. (There are a total of six plug-and-cap assemblies on the crew couch, two per man.) The plug component (bolt) has a nylon insert in the threaded portion that acts as a locking device. Back-and-forth rotation of the adjuster link can cause the plug-and-cap assembly to unscrew from each other. Checks on the four other Apollo 15 assemblies showed zero torque on two of the units and minimum specification value (2.0 in-lb) on the others. The loss of torque is apparently due to cold flow of the plastic self-locking pellet, causing a loss of friction against the mating threads.

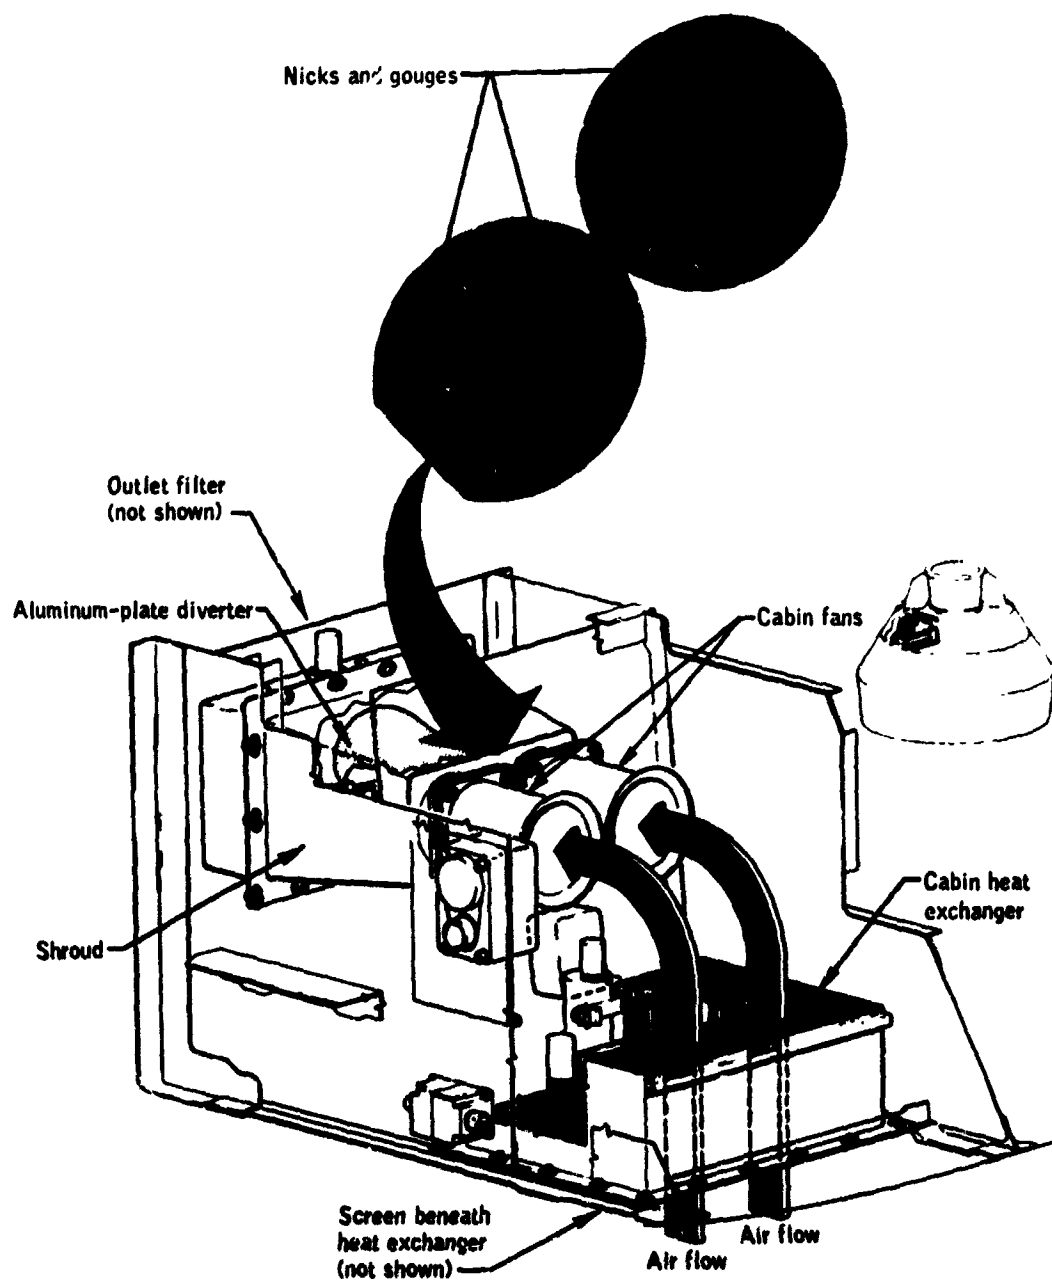
Figure 14-19.- Cabin fan installation.

Inspection of the fans revealed considerable gouging on the leading edges of the blades of both fans (fig. 14-19). No marks were found on the outlet de-swirl vanes of either fan. After extensive examination, including the lunar dust filter, a 1/4-inch washer was found in the ducting.

Although the fan inlet is protected by screens in addition to the heat exchanger core, the outlet is relatively open and the washer could have

drifted in and out when the fans were not operating. The outlet was protected only during the limited time when the lunar dust filter was installed. The washer could also have been left in the duct during assembly.

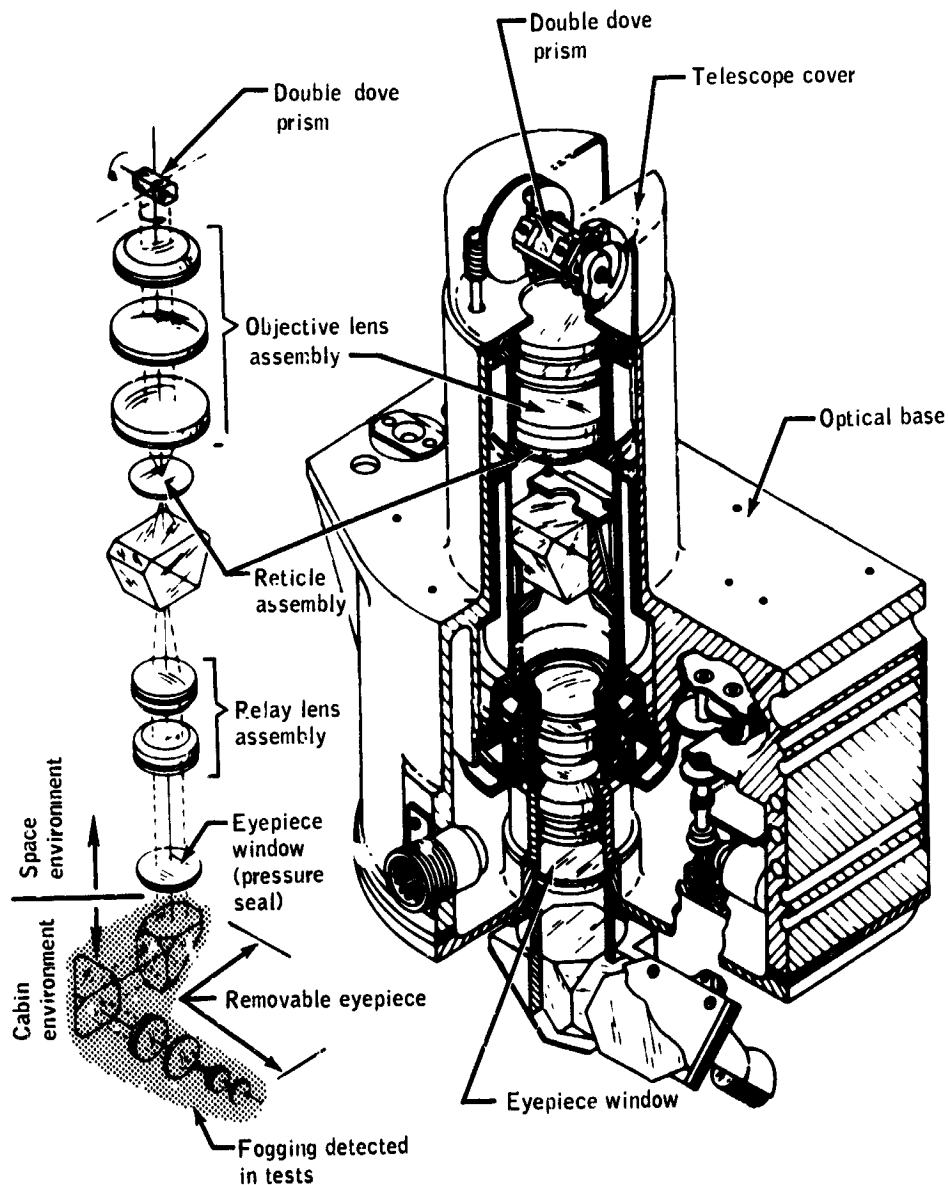
Figure 14-20.- Scanning telescope assembly.

Visual observations through the telescope (fig. 14-20) were made at the spacecraft manufacturer's facility, and no degradation could be observed. A luminescent transmittance test was performed on the telescope before removal from the spacecraft and transmittance was calculated to be 25 percent. This compares with an acceptance test value of 55 percent. The decrease is due to the entry environment and sea water contamination. The 30-percent decrease agrees well with the expected results and is not significant as far as being able to see and recognize constellations is concerned. For comparison, the earth's atmosphere normally causes a 50-percent loss in star intensity; therefore, observing stars from earth with a telescope with a 50-percent transmittance would be equivalent to observing stars from a spacecraft in flight using a telescope with a 25-percent transmittance.

A heater will be added to the removable eyepiece to prevent fogging in the eyepiece assembly and on the eyepiece window.

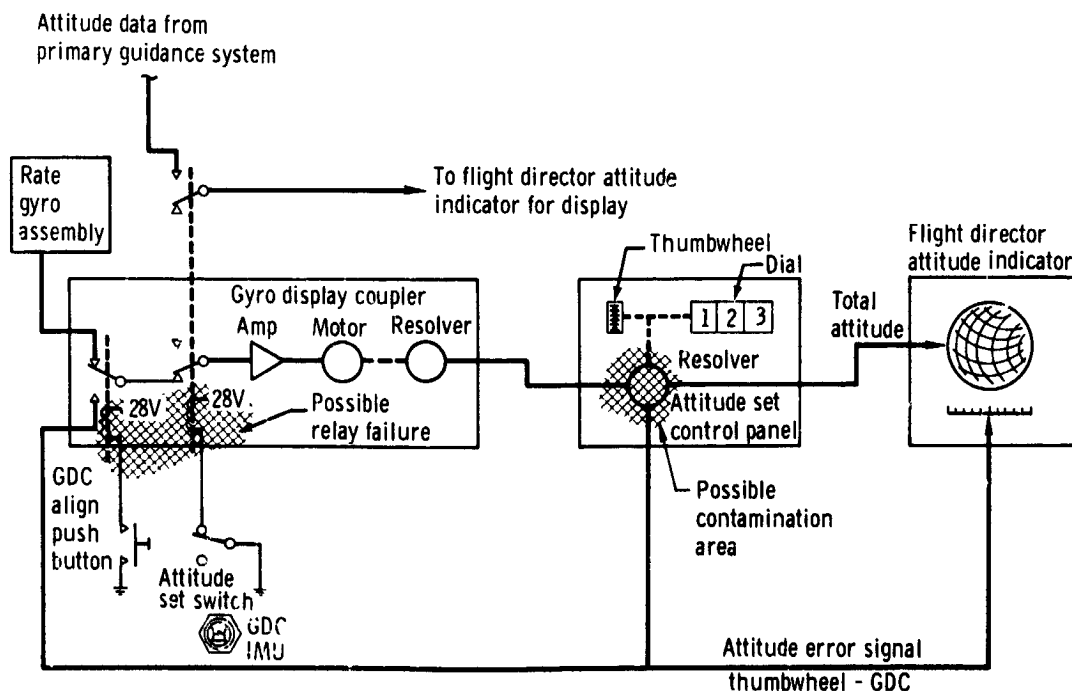
Figure 14-21.- Simplified align loop.

For normal operation during alignment, resolvers in the gyro display coupler electronics are compared to resolvers, one for each axis, on the thumbwheels used to set desired attitude. The difference is an error signal. The error is displayed on the attitude error needles, and the signal is used to drive the resolvers to match the attitude set on the thumbwheels. The anomaly could have been caused by either of two failure modes. An intermittent open in the roll axis align loop or a low gain problem in the electronics (fig. 14-21).

The gyro display coupler and attitude set control panel were put into the hardware evaluator simulator and functionally tested at the systems level in the actual spacecraft configuration in an attempt to repeat the flight problem. During this testing, an out-of-tolerance condition was observed on the attitude set control panel. This condition could have

caused a gain type problem and been the cause of the flight anomaly. The measured resistance of the thumb wheel resolvers increased from the nominal in all three axes by as much as 1000 ohms. Normally, this value does not vary by more than 1 ohm. In order for this condition to have been the cause of the anomaly, a resistance change in the roll axis would have had to be an order of magnitude larger than that measured postflight. The resistance change is caused by contamination between the slip rings and the thumbwheel resolvers. As a result of the flight anomaly, several resolvers were examined and contamination was detected. The corrective action is to wipe the resolvers clean by rotating them several hundred revolutions. The attitude set control panels in Apollo 16 and 17 will be checked and the resolvers will be wiped clean, or will be replaced if necessary.

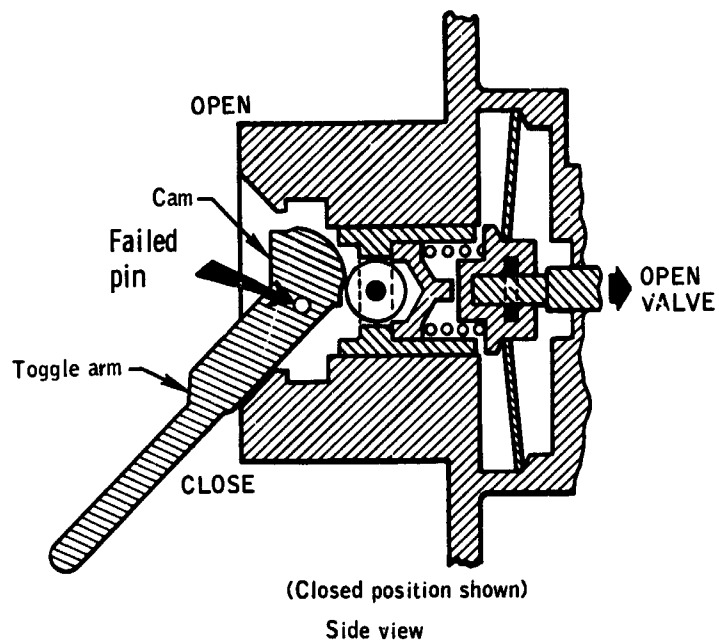
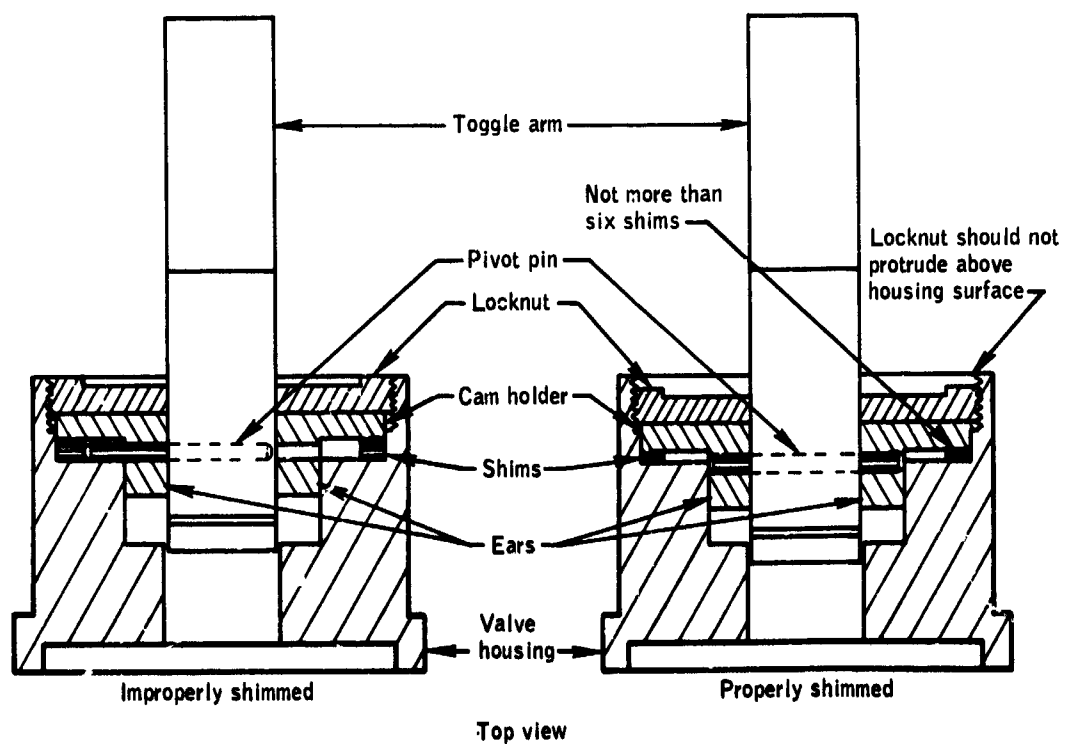
Figure 14-22.- Oxygen regulator shutoff valve.

The pivot pin attaches the toggle arm to the cam holder and is retained in place by the valve housing when properly assembled (fig. 14-22).

Failure analysis showed that the pivot pin failed in single shear and bending. This failure resulted from improper shimming which allowed the pivot pin to come out of one side of the cam holder as shown in figure 14-22. Analysis and testing has shown that the pin strength is adequate in double shear, but will fail in single shear and bending with a force of about 70 pounds applied at the tip of the toggle arm when it is in the closed position. No marks were found on the toggle arm to indicate that it had been struck by some object.

Inspection criteria to assure that valves now installed in other spacecraft are properly assembled have been developed from a study of adverse tolerance buildups associated with the valve components. These criteria are that the lock nut does not protrude and the number of shims does not exceed six (fig. 14-22).
